DANCING WILLOWS METRO DISTRICT
SPECIAL MEETING – 8:00 a.m. @ Dancing Willows Subdivision
Littleton, Colorado

MEETING MINUTES – Management of the “Agreement” between Remington Homes and Dancing Willows Metro District (street repairs) dated 12 December 2011

Subject: Pavement Evaluation
Dancing Willows Subdivision
Littleton, Colorado
Project No. CT15,616-356

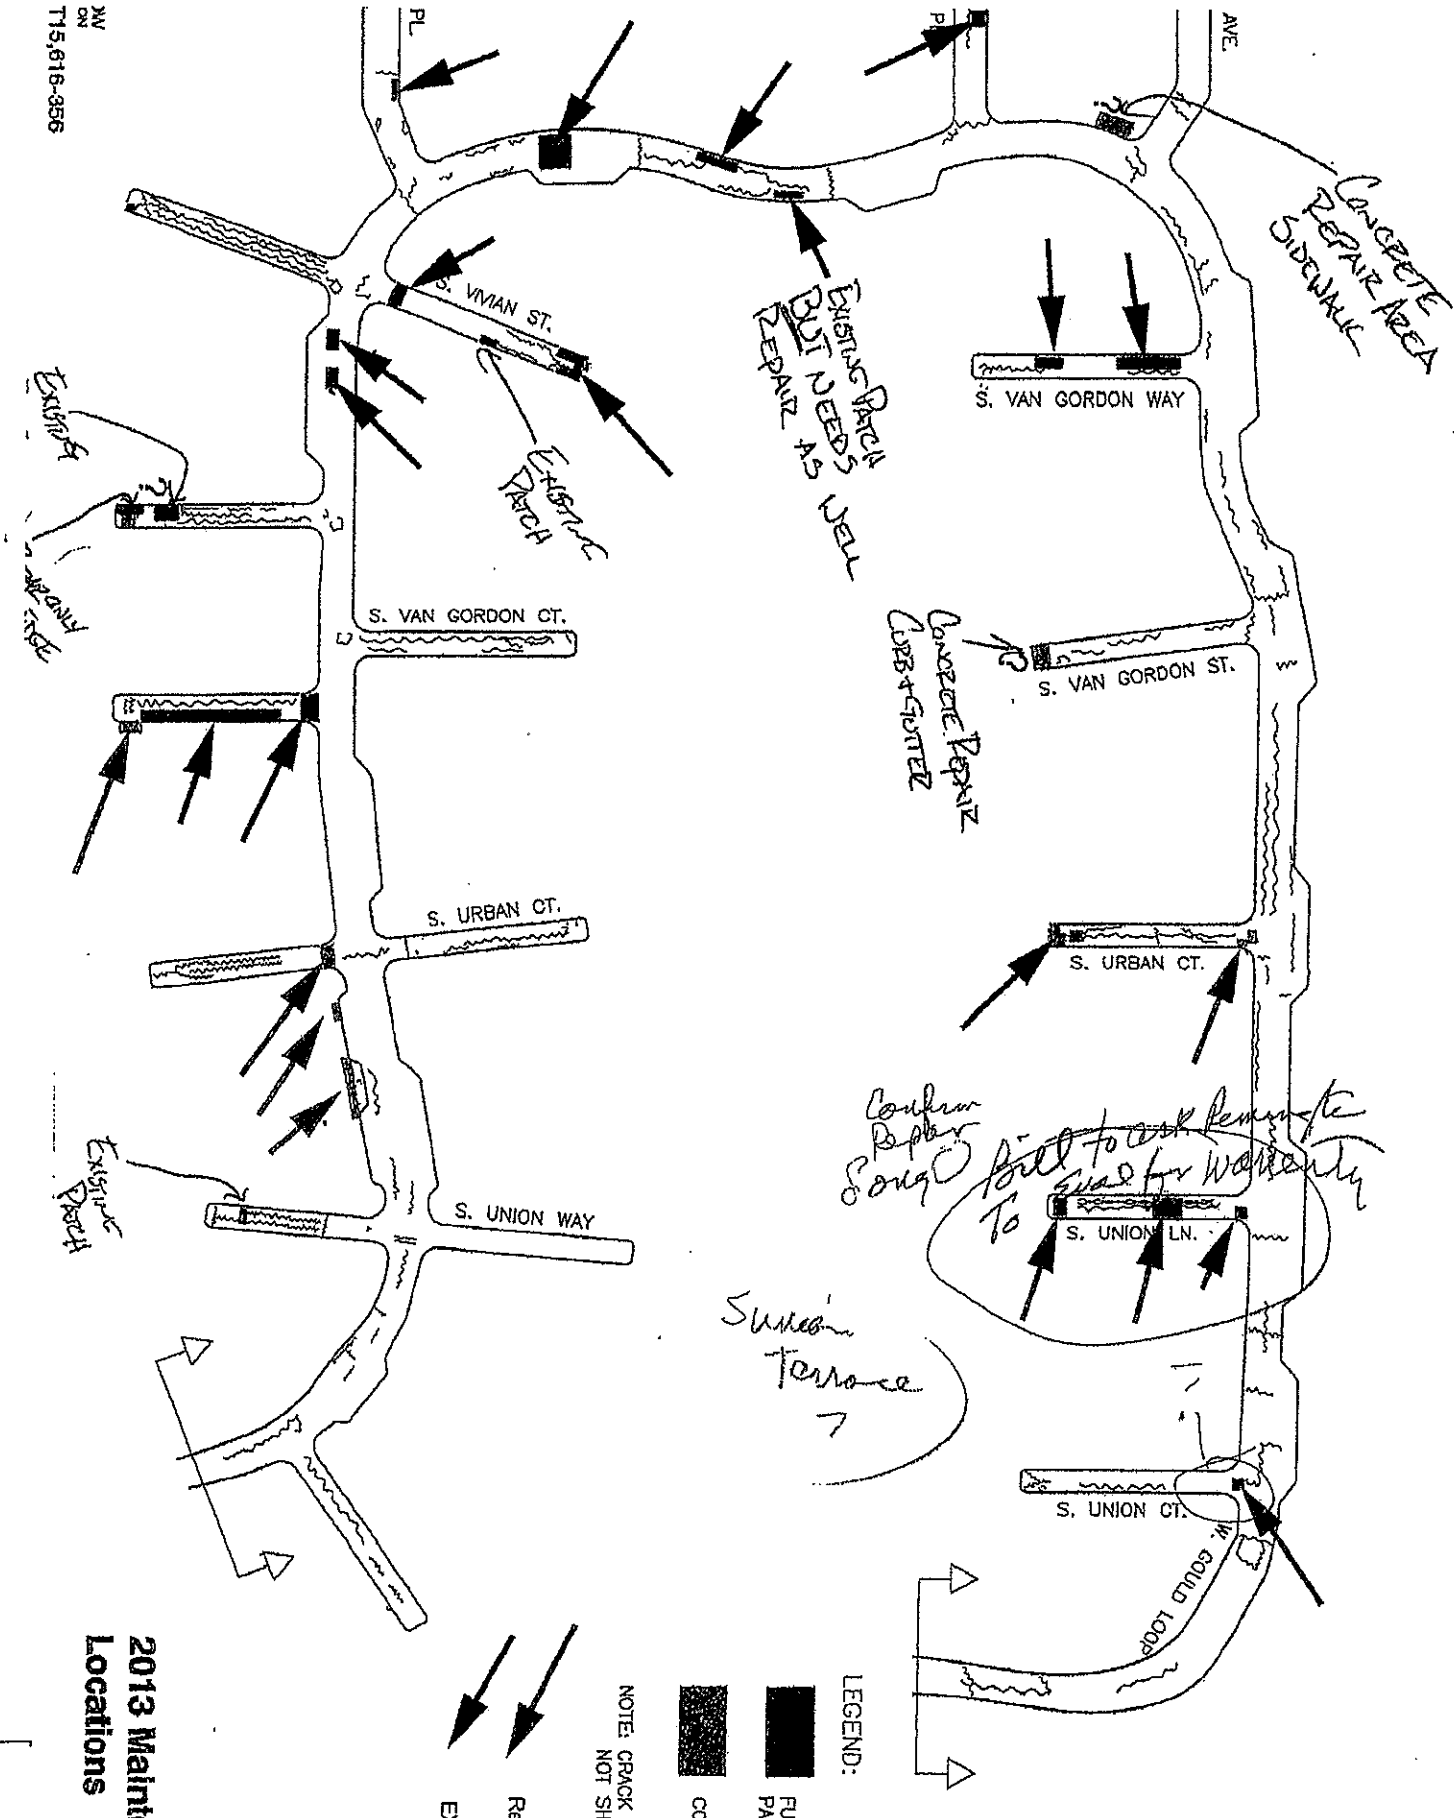
(1) Two drawings indicating DWMD's observation of construction damage to concrete and paving (green arrows).

EXISTING PATCH
POTI NEEDS
REPAIR AS WELL

CONCRETE
REPAIR AREA
SIDEWALK

CONCRETE REPAIR
CURB + GUTTER

CONCRETE REPAIR
TO
SUNSHINE TERRACE
TO ASK PERMITS
FOR WARRANTY

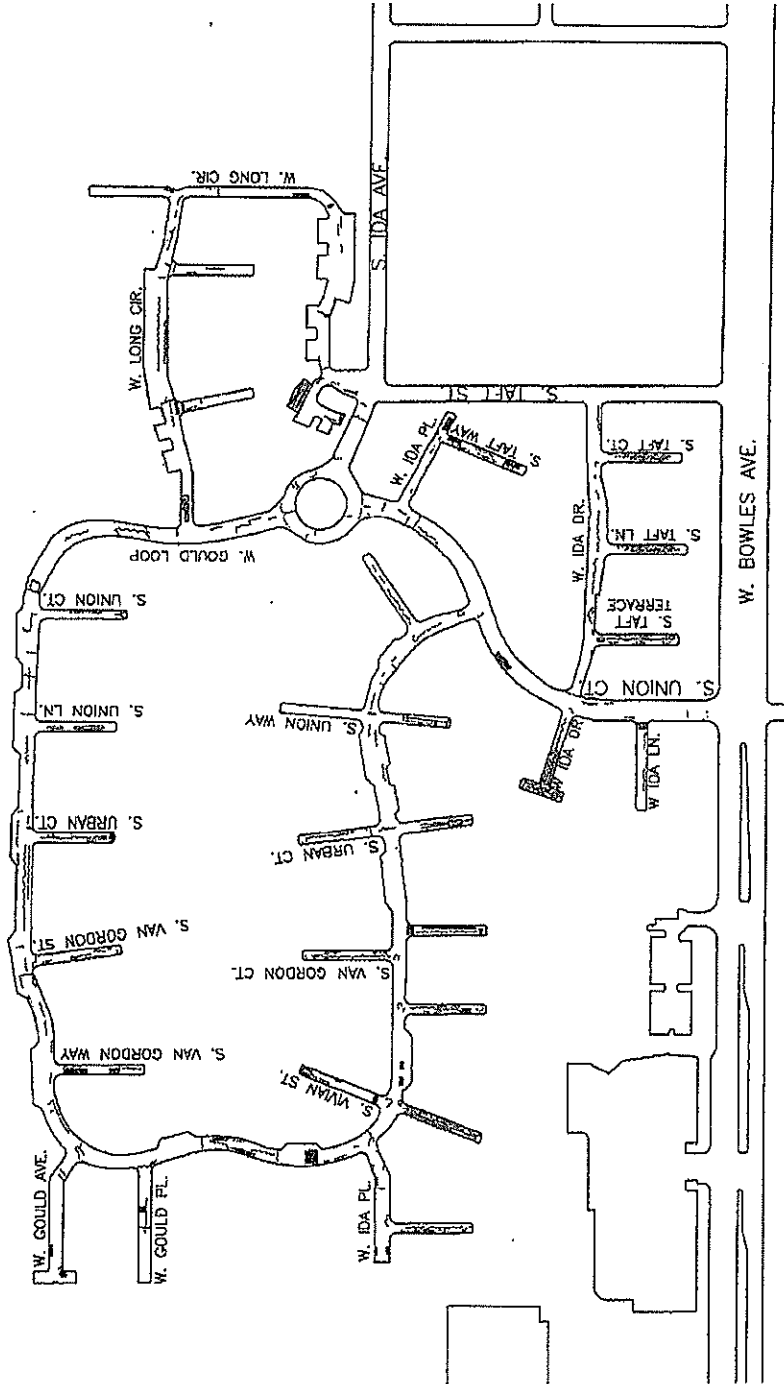
The non-destructive deflection tests were performed on June 4, 2013, using a Benkelman beam and an 18,000-pound single-axle loaded truck. The locations of the 57 tests are shown in Fig. 1 and the results are tabulated in Fig. A-1 and A-2. The tabulation indicates actual deflection measurements and pavement temperatures at the time of testing. These values are adjusted for pavement thickness, temperatures and seasonality. The results are corrected for our critical period of the year (spring) and tabulated in the column headed Representative Rebound Deflection (RRD). The column titled "Final RRD" contains the deflections within the limits created by the RRD. The RRD is calculated as the average deflection plus two standard deviations. This number is used to determine the overall structural capacity of the pavement. The RRD for the streets in Dancing Willows was 0.036. Based on this RRD and Asphalt Institute methods, the estimated service life is greater than 20 years for overall pavement structure (Fig. A-3).

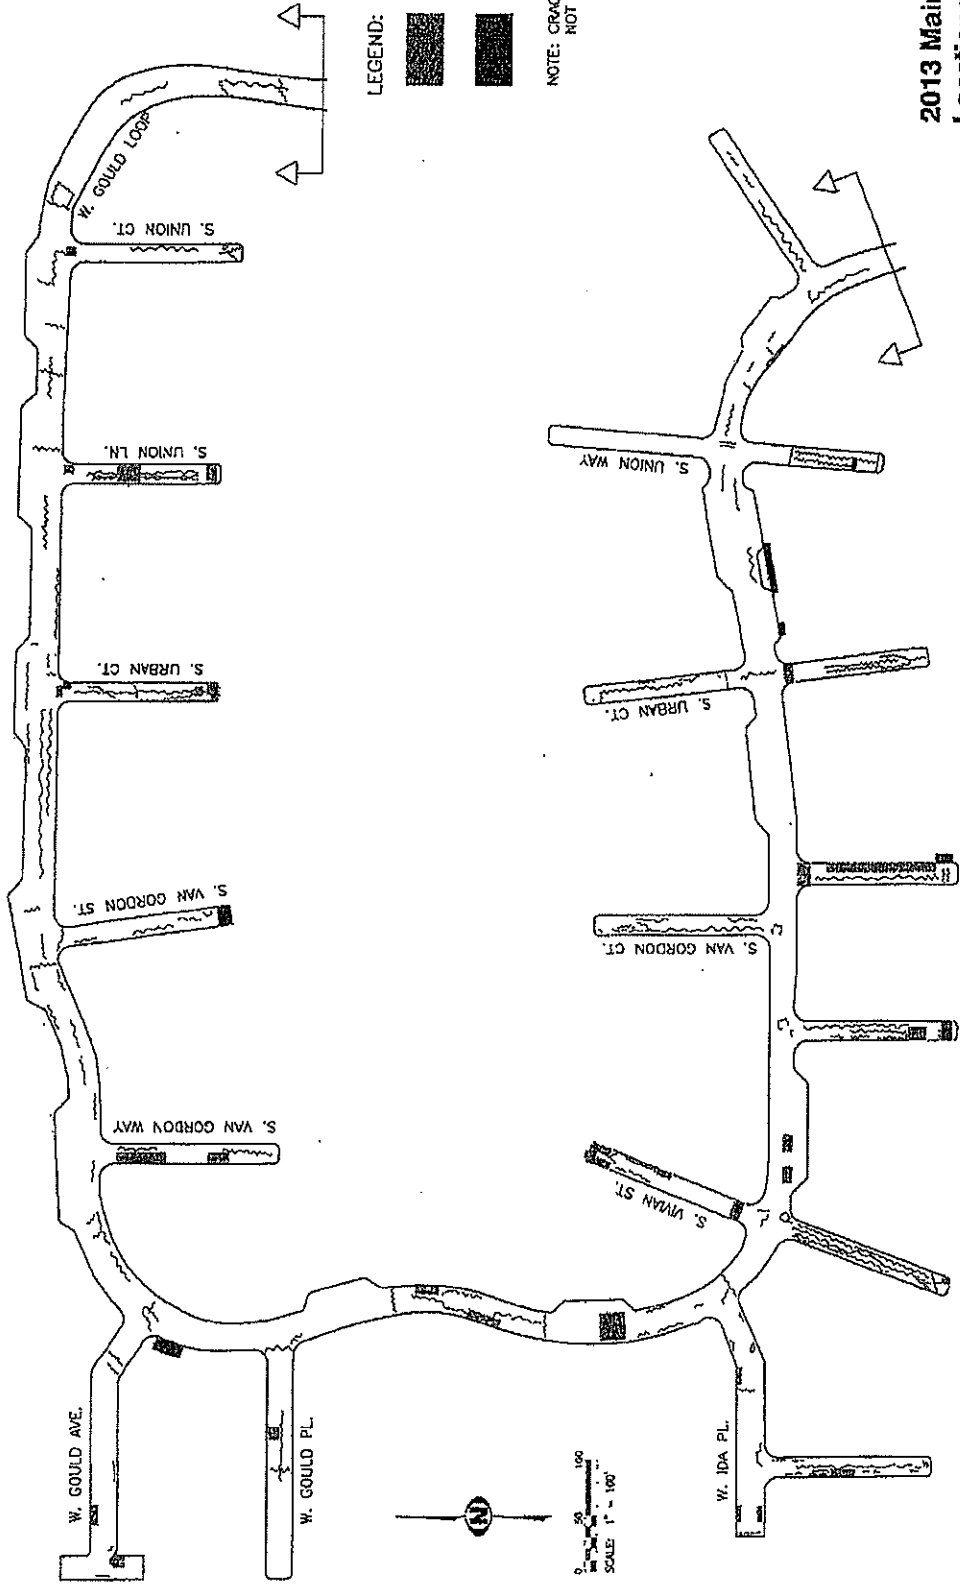
Distress Map Fig. 2

We observed distresses in the form of low to high severity longitudinal/transverse cracking, edge cracking, alligator cracking, potholes and patching. Descriptions of the types of distresses observed are presented below and a pavement distress map is shown on Fig. 2.

- Longitudinal/transverse cracking is a typical distress found in asphalt concrete pavements. These cracks are typically a result of daily and seasonal thermal contraction and expansion of the asphalt concrete. These types of cracks are not load related and are generally not considered as structural problems within the pavement system. However, they do need occasional maintenance treatments.
- Edge cracking is a type of distress that is usually parallel to and usually within 1 to 2 feet of the outer edge of the pavement. This type of distress is typically, caused by either differential movement between the asphalt concrete and the surrounding landscape or by

- Alligator cracking is a series of interconnecting cracks caused by fatigue failure of the asphalt concrete or underlying subgrade under repeated traffic loading. These cracks indicate loss of pavement strength and can be substantiated using non-destructive structural testing, such as the Benkelman Beam deflection testing. Such cracking is considered a major structural distress and if left untreated, will propagate into potholes as a result of deterioration of the asphalt concrete and increased moisture intrusion further reducing soil support.

- Potholes are usually small bowl-shaped depressions in the pavement surface. They generally have sharp and vertical sides near the top of the hole. Potholes are produced when traffic abrades small pieces of the pavement surface and are usually related to structural distresses such as alligator cracking.

- Patches are considered a structural defect no matter the condition of the patch. A patched area or the area adjacent to a patch usually does not perform as well as the original pavement section.
